GAI CONSULTANTS INC MONROEVILLE PA
NATIONAL DAM INSPECTION PROGRAM. RECREATION DAM (NDS ID NUMBER --ETC(U)
MAR 79

PHASE I REPORT
National Dam Inspection Program
Abstract

Recreation Dam (Cold Stream Dam): NDS I.D. No. PA-00446

<u>Owner:</u>	Borough of Philipsburg
<u>State Located:</u>	Pennsylvania (PennDER I.D. No. 14-26)
<u>County Located:</u>	Centre
<u>Stream:</u>	Cold Stream
<u>Inspection Date:</u>	14 and 22 November 1978
<u>Inspection Team:</u>	GAI Consultants, Inc. 570 Beatty Road Monroeville, Pennsylvania 15146

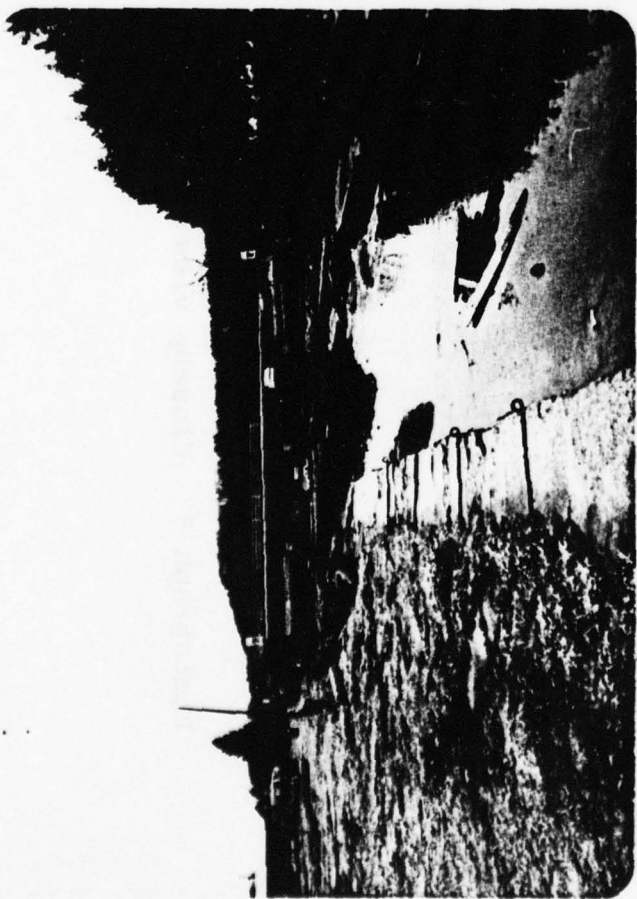
Photograph 1 View of the downstream face of Recreation Dam near the left abutment.

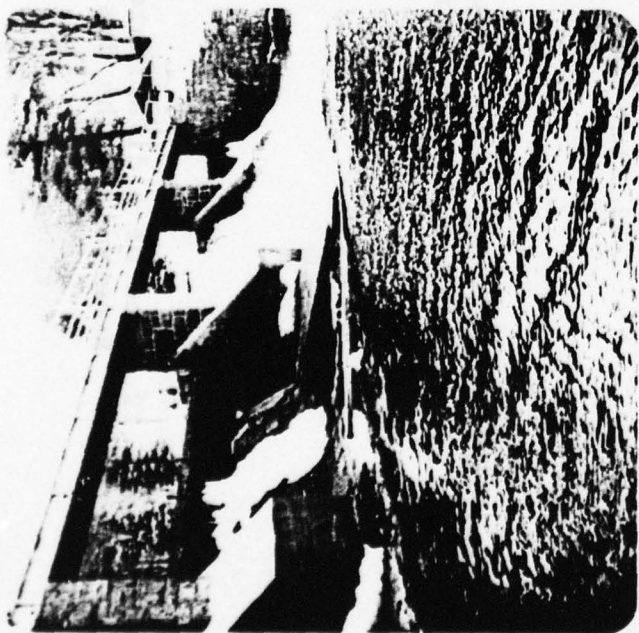
Photograph 9

e. Downstream Channel. As indicated on the Regional Vicinity Map (Appendix G) and in Photograph 9, discharge from Recreation Dam passes through both business and residential areas of Philipsburg. Immediately downstream of the dam (about 500 to 900 feet), Cold Stream passes beneath U.S. Route 322 and PA Route 504, respectively. Several homes and businesses (with an estimated population of twenty) that could be affected by a failure of the embankment are located close to the stream in this area. Thus, the hazard classification for the facility is considered to be "high".

View of the floodplain immediately downstream of the spillway. The bridge in the center of the photo is the first downstream obstruction.

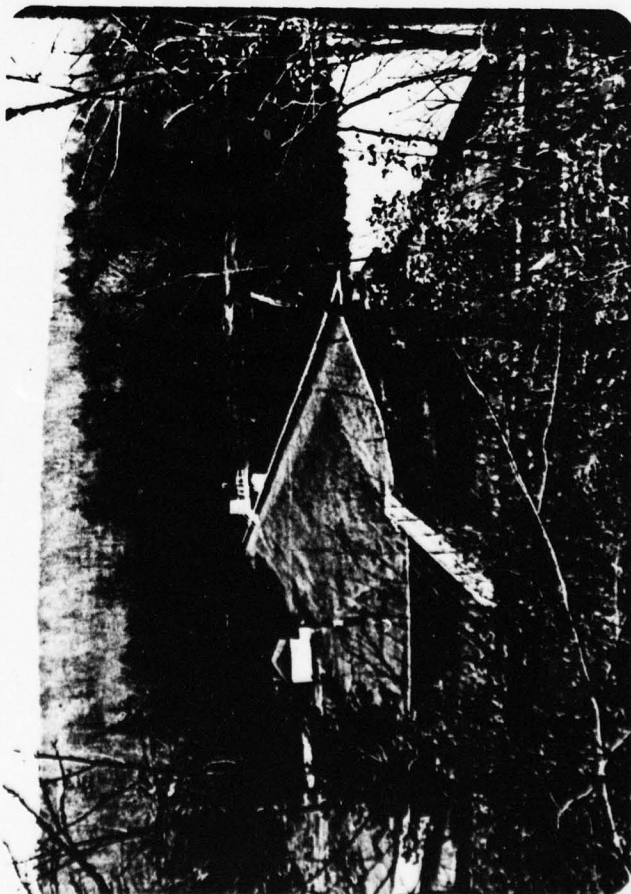
11

d. Reservoir. The reservoir area is a broad sediment filled floodplain in the Cold Stream valley. Side slopes and watershed area are steep and primarily forested. Two upstream impoundments occur within the watershed. The uppermost impoundment, Philipsburg Reservoir Dam (see Photograph 11), is an active facility operated by the Keystone Water Company of Philipsburg. The lower facility is a small, dilapidated structure that has virtually been abandoned but which still impounds some water (see Photograph 12).

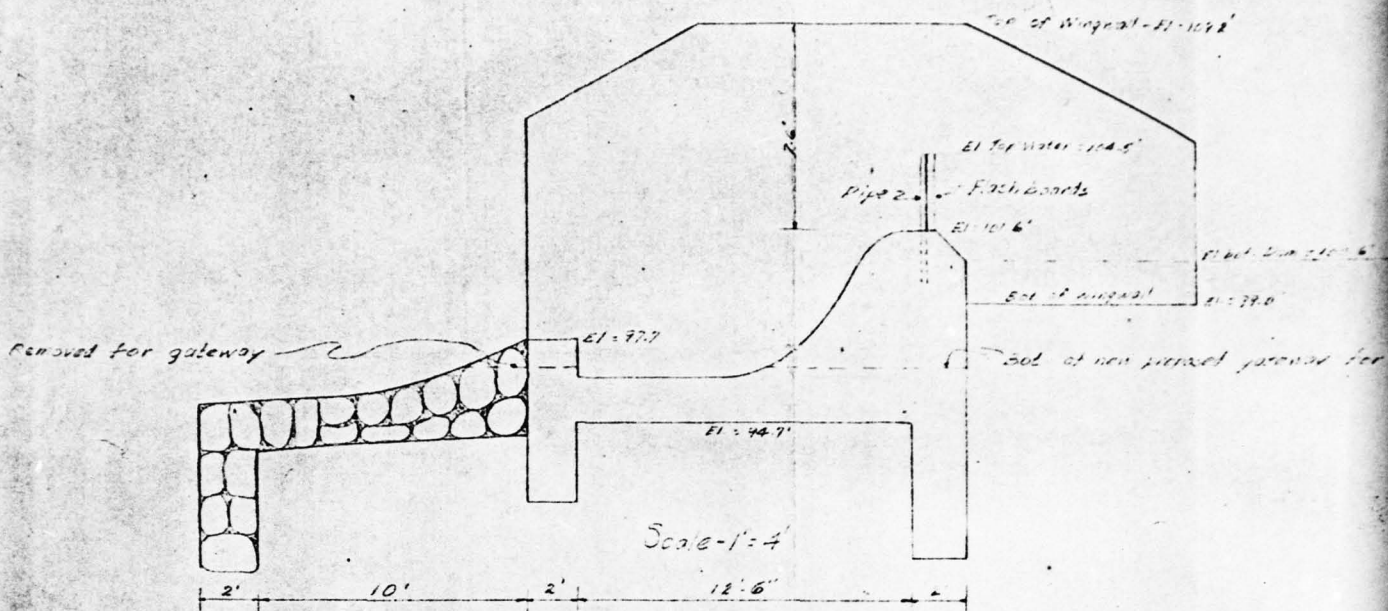
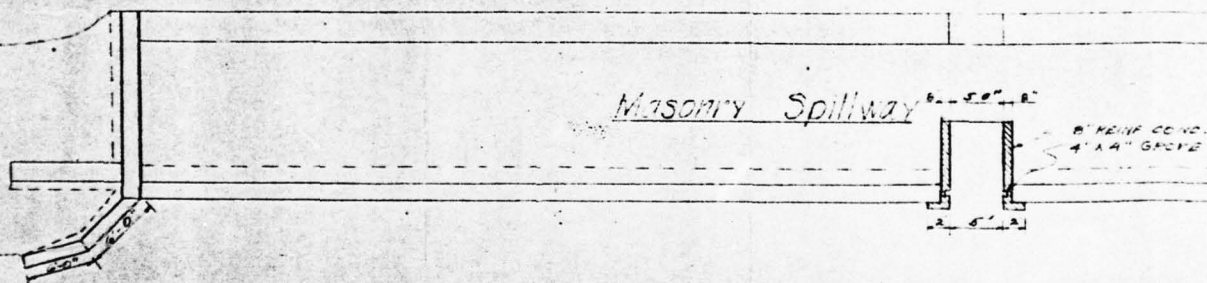
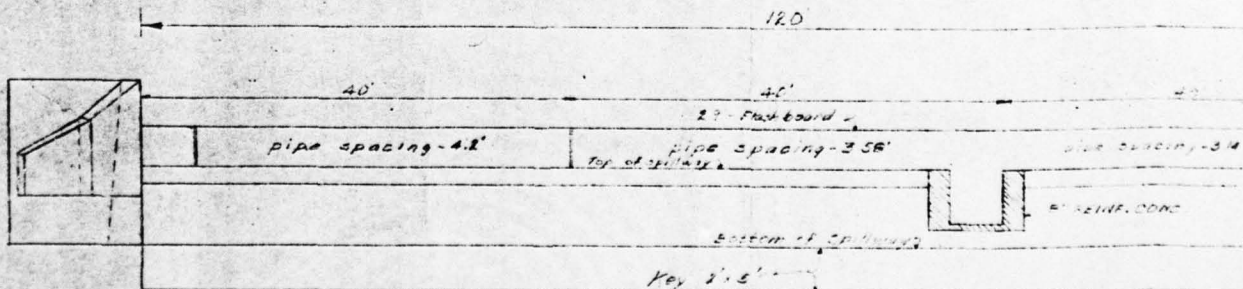
FIGURE 2

2. Appurtenant Structures. The spillway is an uncontrolled masonry structure with an ogee-like crest. Construction photographs and drawings indicate that a cutoff wall (about five feet deep) extends to elevation 89.7 on the upstream side of the spillway, penetrating into the alluvial sands and gravels. A second cutoff wall (about five feet deep) on the downstream end of the spillway apron extends to elevation 91.7 (see Figure 2).

pool level so that it can be used for swimming. Originally, the flashboards were designed to be 35 inches high and to fail under various heads, depending on the spacing of the support pipes (see Figure 2). At the time of inspection, 2 of the 4 spillway bays contained flashboards. Field measurements indicated that the average flashboard height was actually 4 feet.
